GEOTECHNICAL FACTUAL REPORT

PAUARIKI BRIDGE, HIKUWAI ROAD RP0.56 (Bridge #02)

GISBORNE DISTRICT COUNCIL – BRIDGE REPLACEMENT

DOCUMENT NUMBER: CA 2023-001.110.03.08-R1

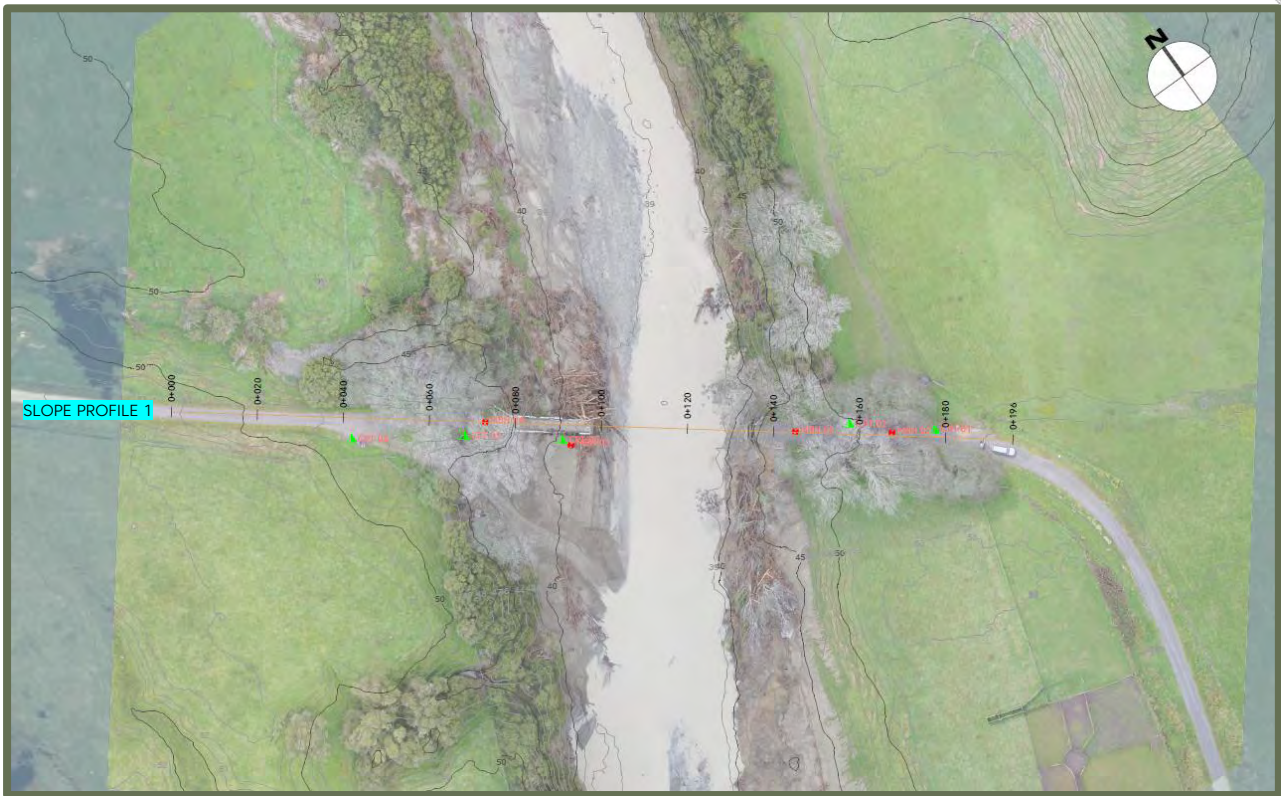
Figure 2-3: Site Topography and Slope profile alignment

The bridge site is situated along the flood plains of the Waiau River and is bounded by hills to the west and east from the Tolaga formation. The hills to the west result from a large fold in the Tolaga unit. The site is near the upper reaches of the Waiau flood plains and so the spread of the flood plain is fairly narrow, being between 250m and 500m wide. The site is at the downstream end of a 700m right hand curve in the river. The Waiau River has more gently sloping banks on the true right-hand side and steeper banks with erosion features on the left and side. The flood plains on the inside of the river bend have indications that the river has moved towards the left-hand bank (west) over the course of its life. This would explain the erosion features on the left-hand bank appearing active despite being heavily forested. The hills surrounding the area are of the Tolaga formation and are heavily incised, notably the western faces.

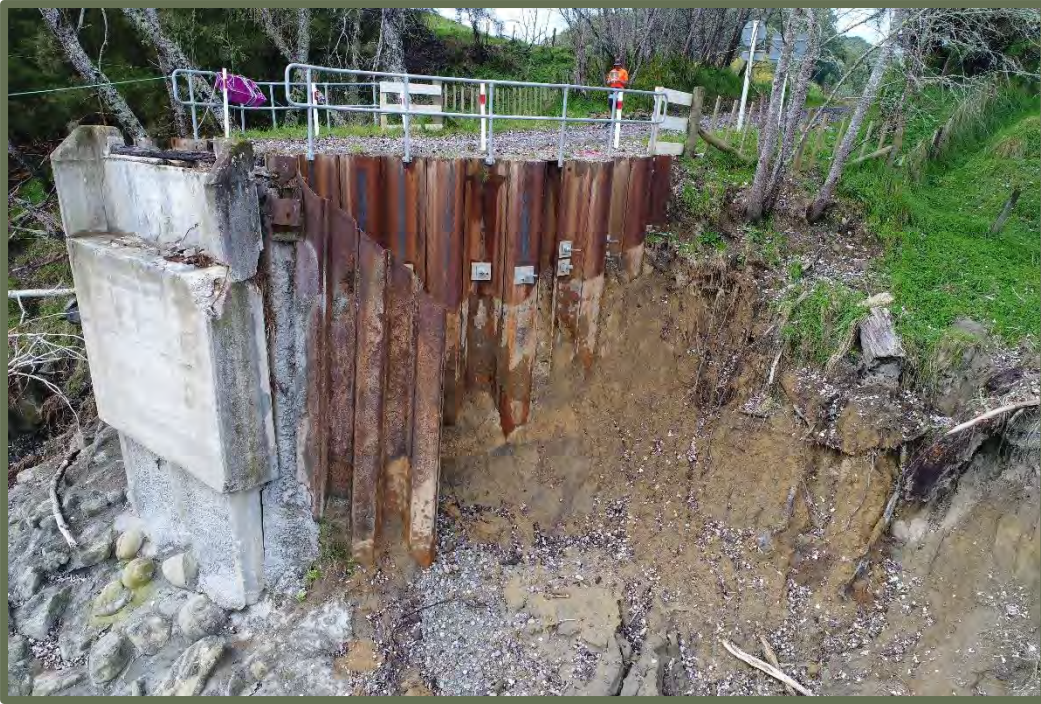
The eastern two spans of the bridge and the abutment were completely destroyed, being dislocated during the cyclone Gabrielle extreme weather event. The western (inland) span remains in place.

Figure 2-6: Current abutment east.

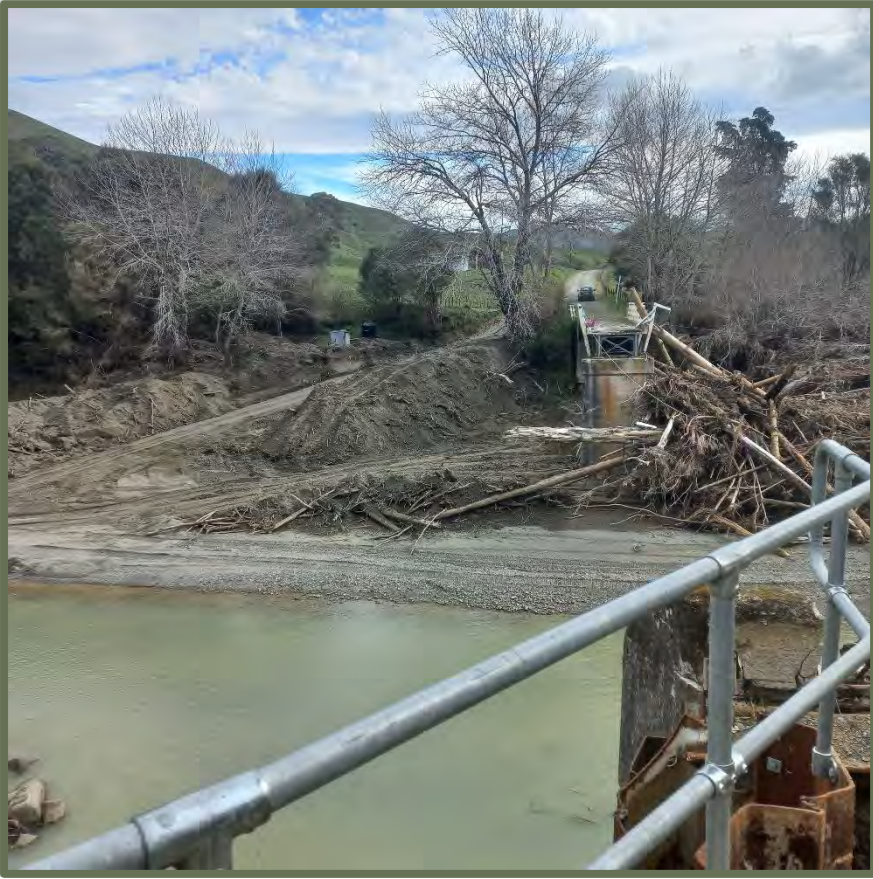
Figure 2-8: Bridge Washed out, east to west view (Civil Assist)

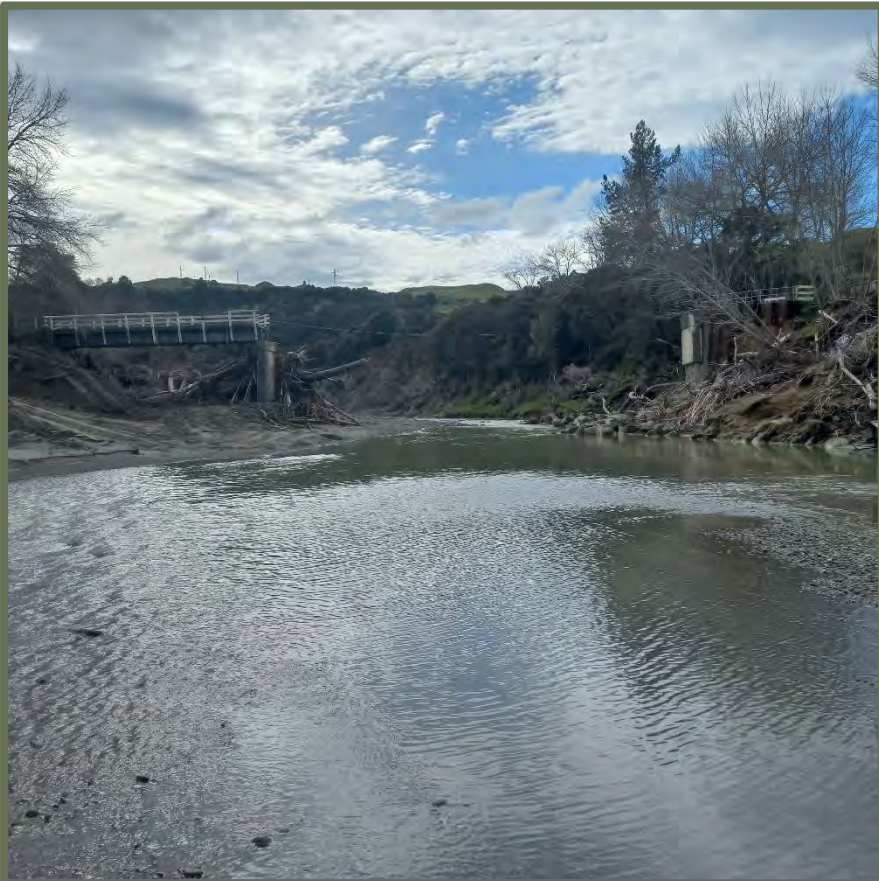
Figure 2-9: Bridge washed out south to north view (Civil Assist).

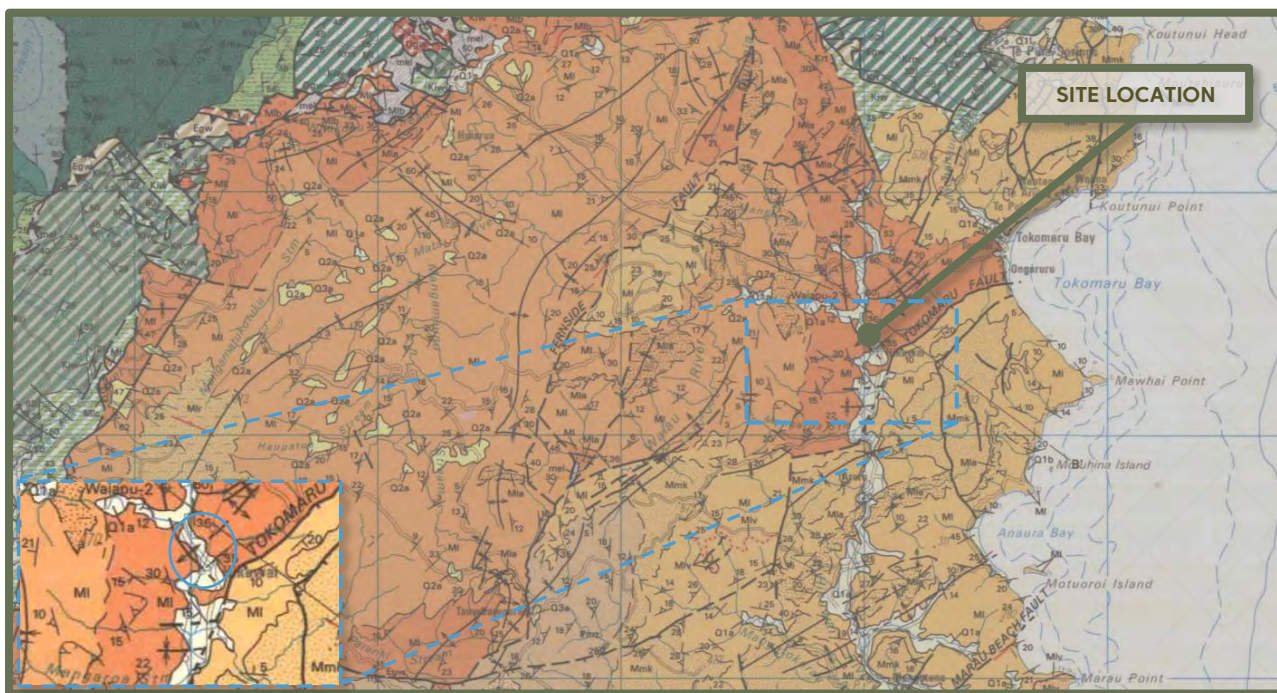
Figure 3-1: Site Geology from 'Geology of Raukumara' GNS Geological Map

The inactive Tokomaru exposed Fault is located approximately 970m east of the Bridge location, total slip unknown, with throw down to southeast displacement information. Another unnamed inactive concealed Fault is located approximately 1.8km south of the bridge location with unknown displacement info.

The nearest active Fault is an unnamed Fault, approximately 3.8km southeast of the site with total slip unknown, with throw down to northeast displacement info.

The general geology of the site summarized above is the integrated output of our site investigation data, the 1:250,000 regional geological maps, and other published and unpublished data.

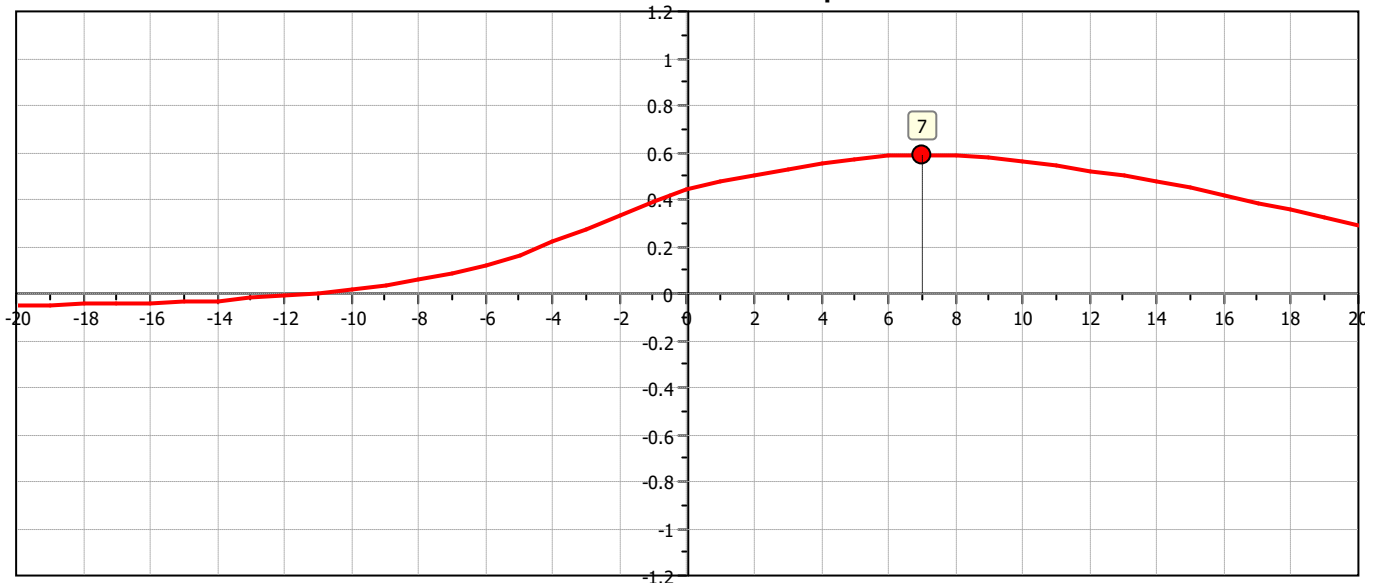
Cross correlation between q_c & f_s

The plot below presents the cross correlation coefficient between the raw q_c and f_s values (as measured on the field). X axes presents the lag distance (one lag is the distance between two successive CPT measurements).

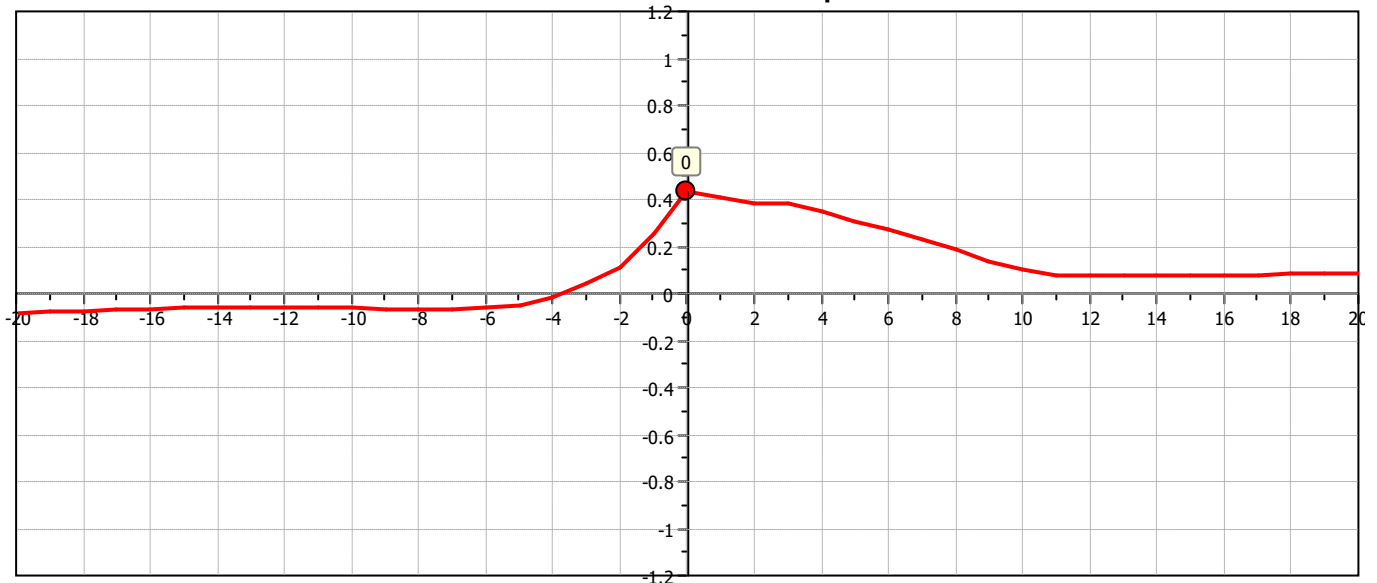
Cross correlation between q_c & f_s

The plot below presents the cross correlation coefficient between the raw q_c and f_s values (as measured on the field). X axes presents the lag distance (one lag is the distance between two successive CPT measurements).

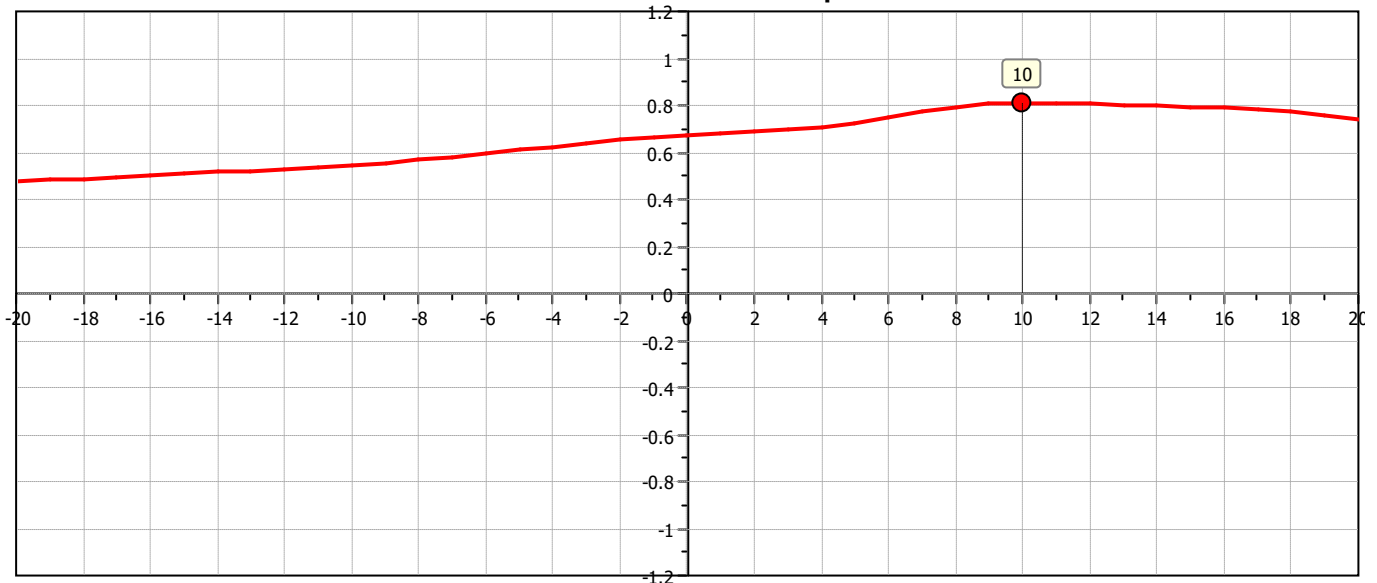
Cross correlation between q_c & f_s

The plot below presents the cross correlation coefficient between the raw q_c and f_s values (as measured on the field). X axes presents the lag distance (one lag is the distance between two successive CPT measurements).

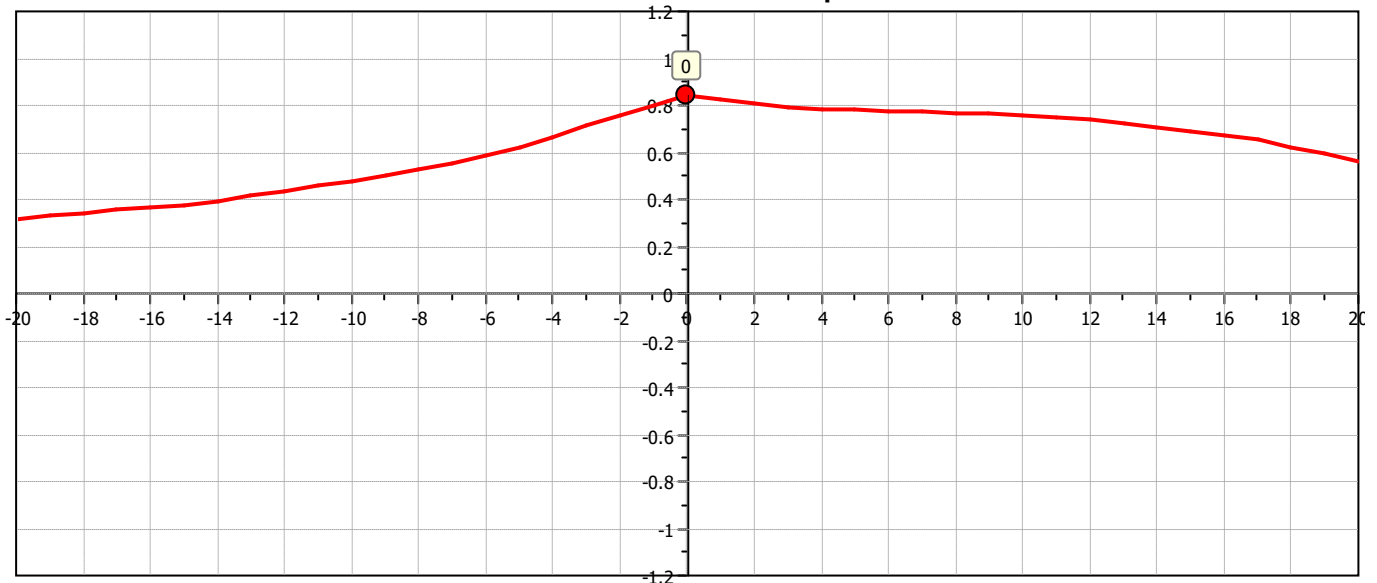
Cross correlation between q_c & f_s

The plot below presents the cross correlation coefficient between the raw q_c and f_s values (as measured on the field). X axes presents the lag distance (one lag is the distance between two successive CPT measurements).

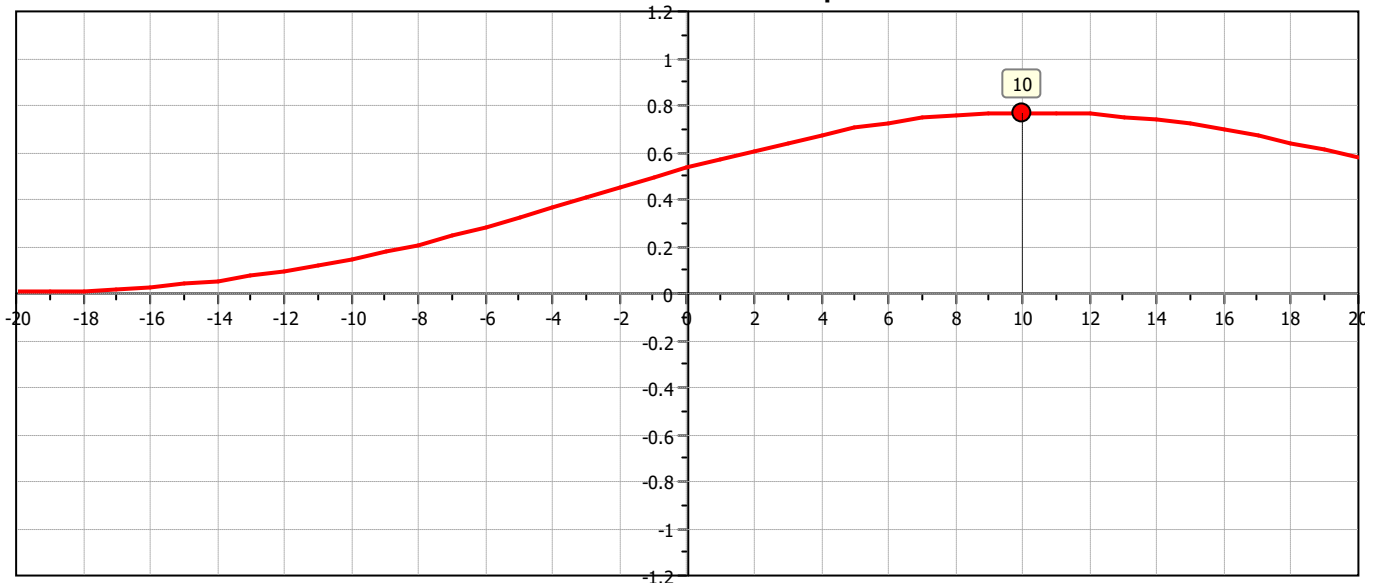
Cross correlation between q_c & f_s

The plot below presents the cross correlation coefficient between the raw q_c and f_s values (as measured on the field). X axes presents the lag distance (one lag is the distance between two successive CPT measurements).

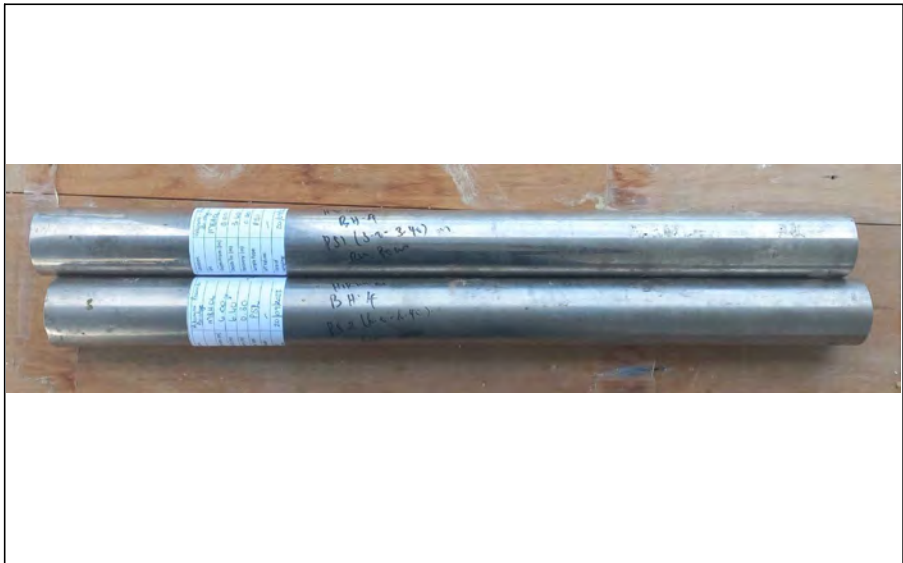
Photo MBH 04.12
Push tube samples

Push tube samples were taken in MBH04, within the compressible soil layers and sealed with molten wax poured into the tube to prevent the samples from losing or adding moisture. The boreholes were terminated between 30m and 35m depth below existing ground level.

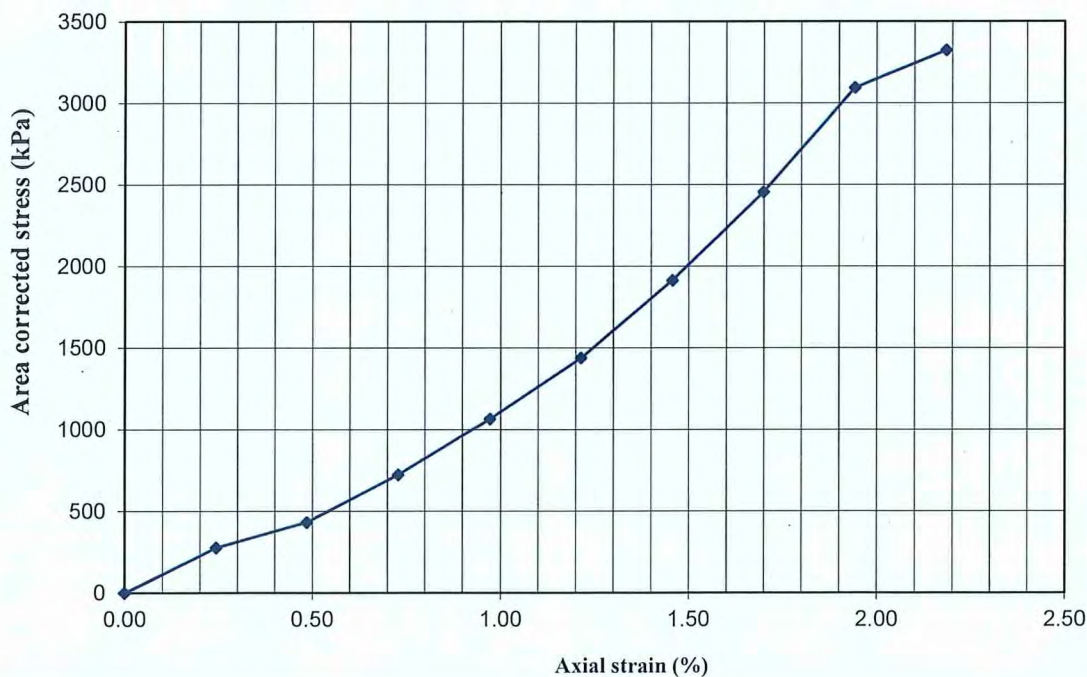
Area corrected Stress (kPa) Vs Axial strain (%)

Test results			
Bulk density (t/m ³)	2.33	Initial sample diameter (mm)	60.6
Water content (%)	Not Tested	Initial sample length (mm)	103.0
Dry density (t/m ³)	Not tested	Initial sample area (mm ²)	2884.3
Maximum stress (kPa)	3324	Initial Length:Diameter ratio	1.7:1
Strain at failure (%)	2.2	Young's modulus (MPa)	183
Mode of failure:	Vertical Shear	For strain range	0.49 - 1.94%

Test Methods	Notes
UCS: NZS 4402: 1986: Test 6.3.1	-Sample Descriptions are not covered by IANZ accreditation. -The strain rate for this test was kept constant at 1.0mm/min. -Test method requires approx. 2:1 (L:D) ratio. This test deviates from that.

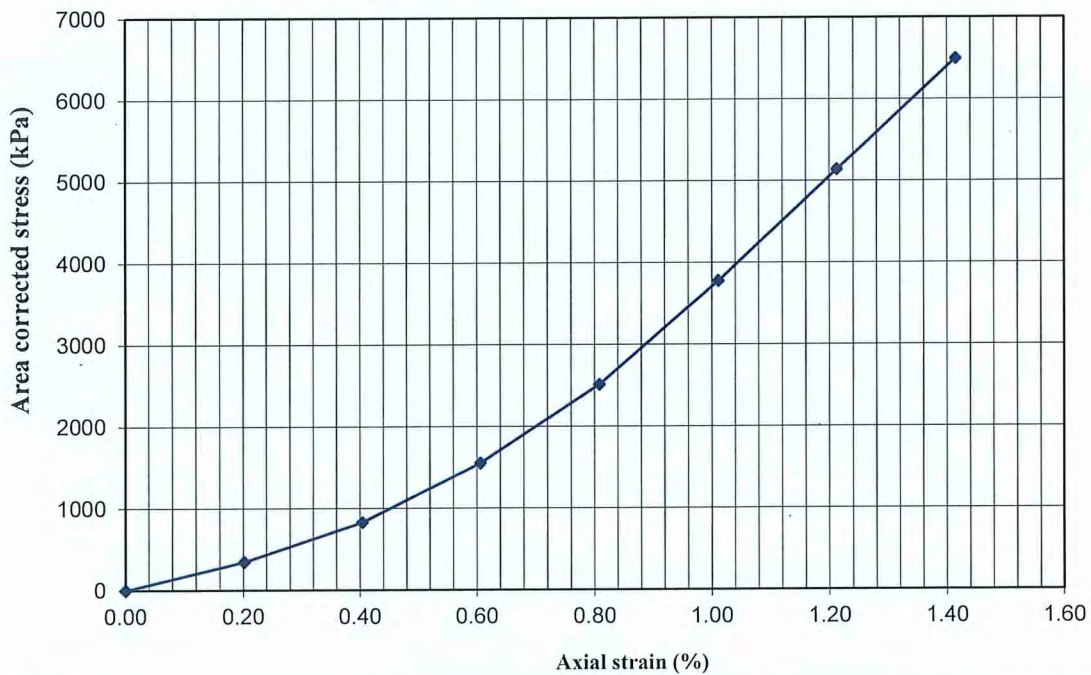
Area corrected Stress (kPa) Vs Axial strain (%)

Test results			
Bulk density (t/m ³)	2.36	Initial sample diameter (mm)	60.6
Water content (%)	Not Tested	Initial sample length (mm)	123.7
Dry density (t/m ³)	Not tested	Initial sample area (mm ²)	2884.3
Maximum stress (kPa)	6494	Initial Length:Diameter ratio	2.04:1
Strain at failure (%)	1.4	Young's modulus (MPa)	611
Mode of failure:	Vertical Shear	For strain range	0.61 - 1.42%

Test Methods	Notes
UCS: NZS 4402:1986: Test 6.3.1	-Sample Descriptions are not covered by IANZ accreditation. -The strain rate for this test was kept constant at 1.0mm/min.

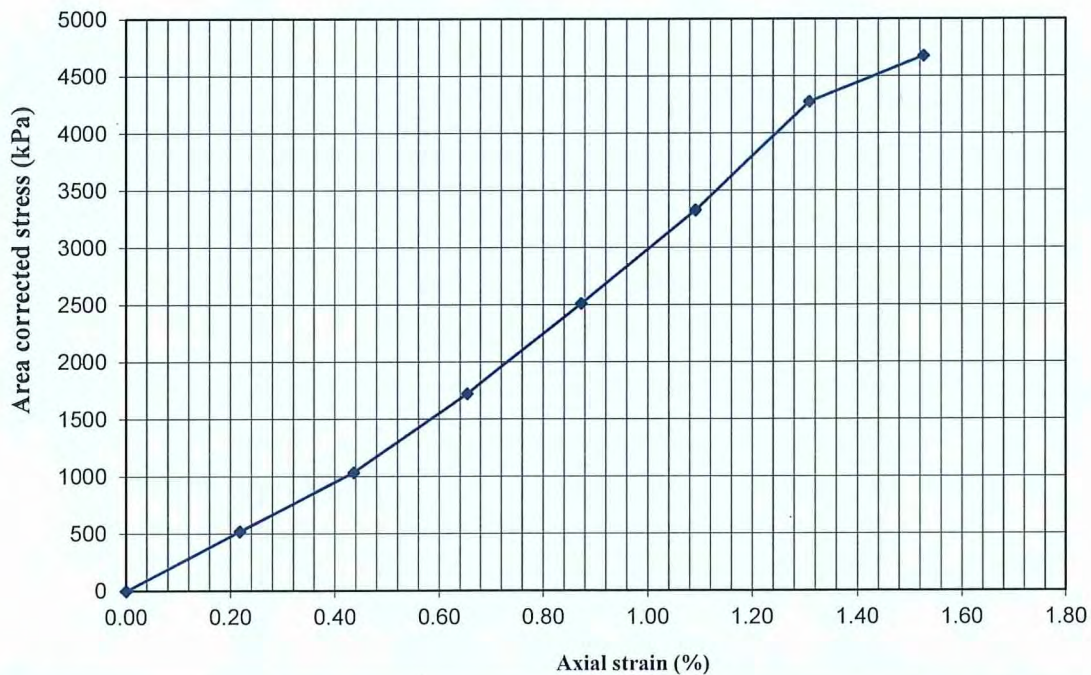
Area corrected Stress (kPa) Vs Axial strain (%)

Test results			
Bulk density (t/m ³)	2.29	Initial sample diameter (mm)	60.6
Water content (%)	Not Tested	Initial sample length (mm)	114.6
Dry density (t/m ³)	Not tested	Initial sample area (mm ²)	2884.3
Maximum stress (kPa)	4677	Initial Length:Diameter ratio	1.89:1
Strain at failure (%)	1.5	Young's modulus (MPa)	371
Mode of failure:	Vertical Shear	For strain range	0.44 - 1.31%

Test Methods	Notes
UCS: NZS 4402: 1986: Test 6.3.1	-Sample Descriptions are not covered by IANZ accreditation. -The strain rate for this test was kept constant at 1.0mm/min.
